**Safety investigation in students' residential  
buildings using Hazard Identification Risk Analysis  
and Risk Control**

## 2 Safety investigation in students' residential buildings using Hazard Identification Risk Analysis and Risk Control

**Keywords:** HIRARC, Barn Swallow, Residency Building

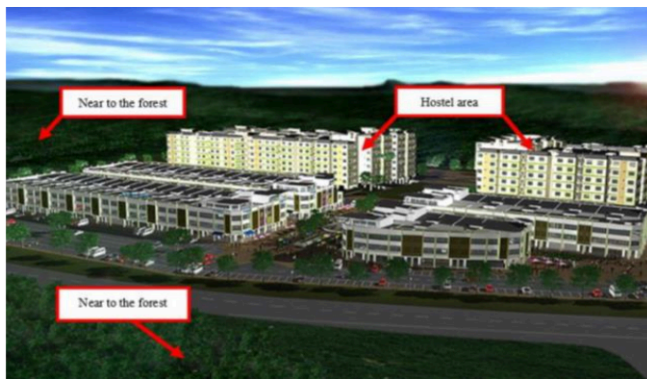
Figure 1. Students' Residency Buildings Complex

This study focuses on a specific case involving residential buildings housing 4,000 students affiliated with a local university. Among the examined blocks (A1, A3, and A4), Block A2 was identified as the primary site of Barn Swallow habitation, likely due to its central location within the residential complex and proximity to a pond. The U-shaped, six-floor structure, with 27 units per floor, features architectural elements that facilitate avian nesting and perching, particularly along pipelines and window ledges. The birds' presence has necessitated regular cleaning interventions to mitigate contamination risks, as illustrated in Figure 1. Research on Barn Swallow habitat preferences indicates their affinity for open areas, access to water sources, and specific architectural features conducive to nest construction [7].

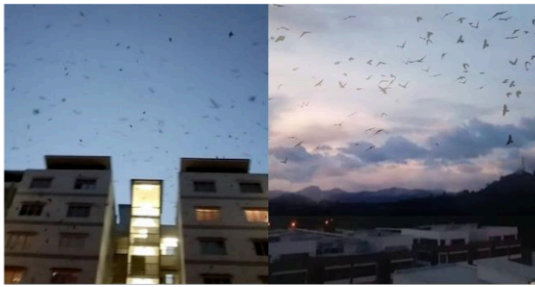
Figure 3 illustrates the temporal patterns of avian activity within the residential buildings. The data reveal that barn swallows (*Hirundo rustica*) exhibited peak activity during the early morning and dusk periods. During these times, the birds were observed engaging in foraging behaviour, departing from their nests in search of food, and subsequently returning to rest. This cyclical activity pattern coincided with increased noise levels, which were reported to cause disturbances among the student residents. The noise generated by the birds during their return to nesting sites was identified as a significant source of annoyance, impacting the living conditions of the occupants. These observations highlight the temporal correlation between avian activity and resident discomfort, underscoring the need for targeted mitigation strategies to address noise-related issues.

Figure 3. Barn Swallow reside the buildings at night time

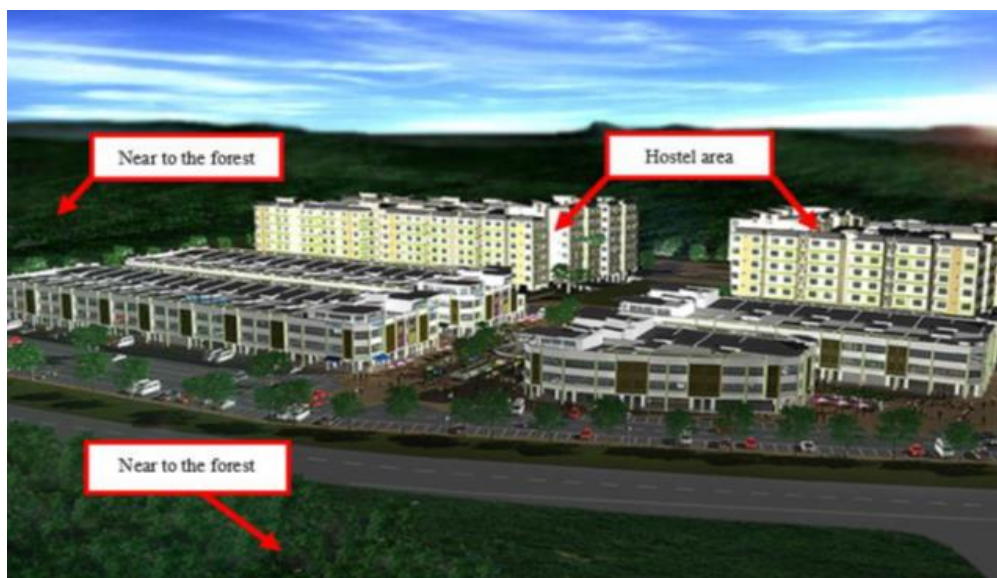
**Figure 1.** Students' Residency Buildings Complex

This study focuses on a specific case involving residential buildings housing 4,000 students affiliated with a local university. Among the examined blocks (A1, A3, and A4), Block A2 was identified as the primary site of Barn Swallow habitation, likely due to its central location within the residential complex and proximity to a pond. The U-shaped, six-floor structure, with 27 units per floor, features architectural elements that facilitate avian nesting and perching, particularly along pipelines and window ledges. The birds' presence has necessitated regular cleaning interventions to mitigate contamination risks, as illustrated in Figure 1. Research on Barn Swallow habitat preferences indicates their affinity for open areas, access to water sources, and specific architectural features conducive to nest construction [7].

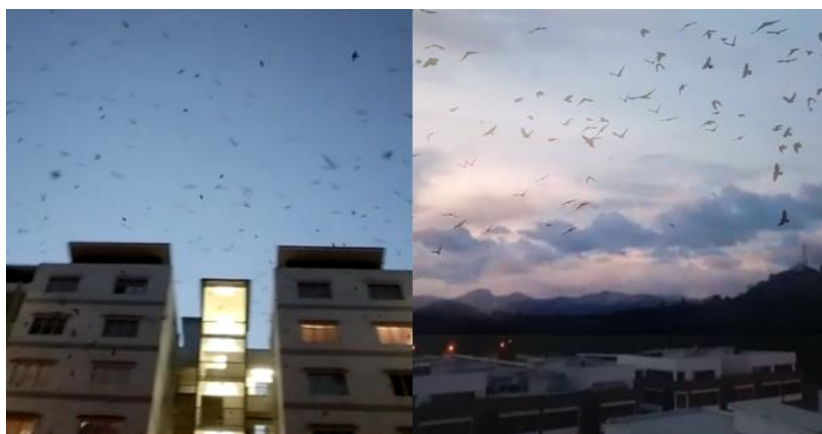
Figure 3 illustrates the temporal patterns of avian activity within the residential buildings. The data reveal that barn swallows (*Hirundo rustica*) exhibited peak activity during the early morning and dusk periods. During these times, the birds were observed engaging in foraging behaviour, departing from their nests in search of food, and subsequently returning to rest. This cyclical activity pattern coincided with increased noise levels, which were reported to cause disturbances among the student residents. The noise generated by the birds during their return to nesting sites was identified as a significant source of annoyance, impacting the living conditions of the occupants. These observations highlight the temporal correlation between avian activity and resident discomfort, underscoring the need for targeted mitigation strategies to address noise-related issues.

**Figure 3.** Barn Swallow reside the buildings at night time
