# American Journal of Multidisciplinary Research & Development

**ABSTRACT:** This study evaluates the spatial-physical alignment of the Glodok Urban Corridor against Building and Environmental Plan (RTBL) standards, focusing on building forms and pedestrian circulation networks. A comparative evaluation matrix was applied across 16 sub-areas to examine regulatory deviations and their impacts on urban heritage and pedestrian safety. The findings reveal massive, systemic violations of building setbacks within the interior core, driven by organic, self-built structures encroaching upon the public right-of-way and air rights. This encroachment causes severe vertical scale friction and degrades the architectural identity of historic Chinese Pecinan vernacular facades. At the macro scale, the corridor exhibits high transit-oriented development potential. However, micro-connectivity is functionally paralyzed by severe side friction, including illegal on-street parking, logistics conflicts, and total pedestrian displacement by traditional market stalls. Furthermore, the complete absence of segregated walkways and universal design features forces vulnerable users into hazardous shared spac

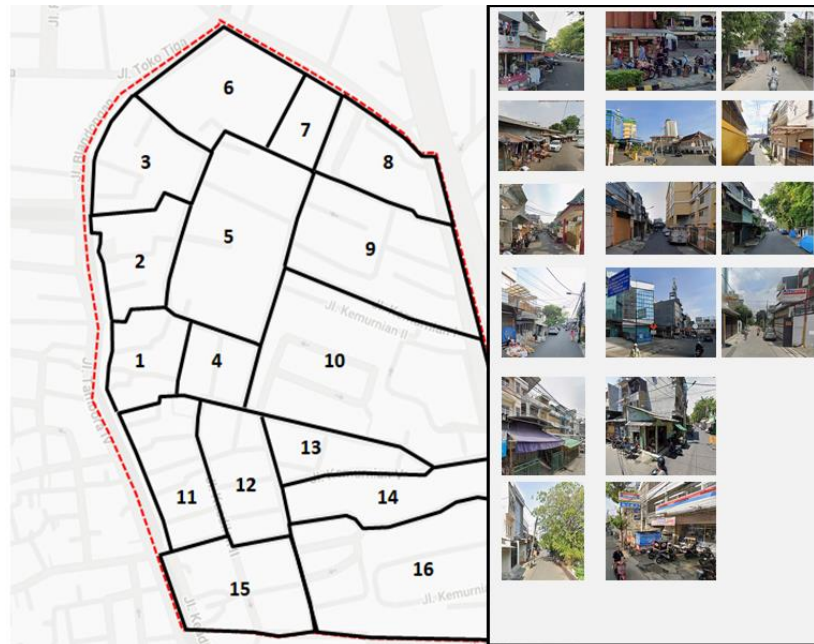
**Fig 3. building layout conditions in the glodok area, Jakarta, Indonesia**  
source : google mapa,2026

1) Building Setback Deviations (GSB/GMB): Strict and high compliance with building setback regulations is rigidly limited to sub-sectors directly adjacent to primary arterial corridors, most notably Sector 8 (which encompasses modern, large-scale blocks such as Pasar Jaya Glodok) and Sector 10. These areas exhibit organized building clearance distances and controlled podium alignment. Conversely, massive, systemic violations of the Building Setback Line (GSB) and Building Frontage Line (GMB) serve as the defining characteristics of the interior core [25]. In Sectors 1, 2, and 3, structures have grown organically without standardized lot boundaries or visual orientation. This spatial compromise reaches a critical threshold in Sectors 6, 11, and 15, where self-built residential and commercial structures horizontally extend upper-floor structures (balconies), permanent canopies, and external iron staircases to the extent of encroaching upon the public right-of-way within narrow alleys, thereby constricting public air rights and blocking natural light penetration.

A comparative analysis of the building form and massing characteristics across the 16 selected sub-sectors reveals deep spatial fragmentation and a sharp structural dualism within the Glodok Urban Corridor. The physical fabric of the city is divided into two contrasting typologies: a formal-modern structure regulated by macro-planning systems, and organic-informal vernacular settlements that have grown spontaneously over time [24].

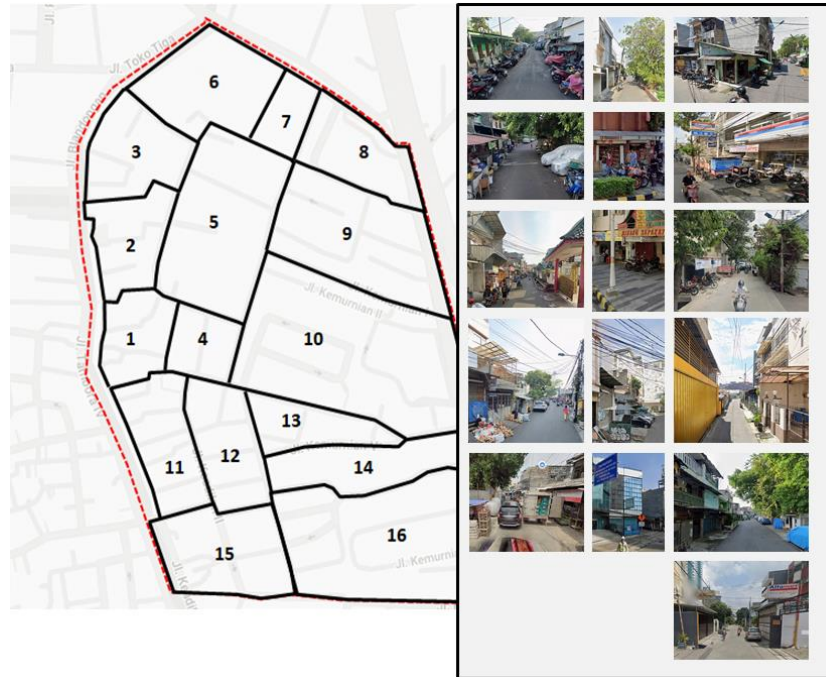
**Fig 4 . Condition of circulation and pedestrian systems in the glodok area, Jakarta, indonesia**  
source : google mapa,2026

- 1) **Pedestrian Space Deprivation and Shared Space Vulnerability:** Human-centered design is virtually non-existent across the entire internal network [15]. In Sector 6, the primary corridor of Pancoran Street operates as a highly congested, unregulated shared space where pedestrians, moving motorcycles, private vehicles, and informal commercial loading and unloading activities actively contest the same asphalt surface. Within the inner hinterland areas specifically Sectors 1, 2, 11, and 15 the physical street geometry is highly constrained, with path widths limited to a mere 1.5 to 3.5 meters. Several bottlenecks are so narrow that they can only accommodate one motorcycle at a time, yet these pathways remain severely obstructed by chaotic on-street motorcycle parking and the encroachment of residential domestic activities. The most severe degradation of pedestrian infrastructure occurs in Sector 100, where the public right-of-way for pedestrians is 100% occupied and physically overtaken by traditional wet market vendor stalls, triggering the total displacement of pedestrians and comprehensive spatial paralysis.

- 3) **Transit Integration and Non-Motorized Transport Barriers:** From a macro-planning perspective, Sectors 8 and 10 exhibit optimal Transit-Oriented Development (TOD) potential due to their direct spatial connectivity to Gajah Mada Street, the Transjakarta mass transit corridors, and the catchment areas of future MRT stations. However, this regional accessibility is severely degraded at the micro-level. The interconnecting sidewalks in Sector 8 suffer from profound functional degradation due to continuous encroachment by illegal motorcycle parking, street vendors, and commercial shop-house logistics. Furthermore, dedicated non-motorized transport corridors (bicycle lanes) are impossible to implement in Sectors 4, 5, 11, 12, 13, and 15 due to restricted street geometry, logistical box truck loading and unloading operations, and uncontrolled on-street illegal parking, effectively blocking opportunities for sustainable transit network modernization.

An evaluation of the circulation network highlights a fundamental misalignment between vehicle-centric infrastructure and human-centered design principles within a dense, historic urban core. The entire corridor experiences high local side friction, spatial paralysis, and a critical loss of safe spaces dedicated to non-motorized transportation.

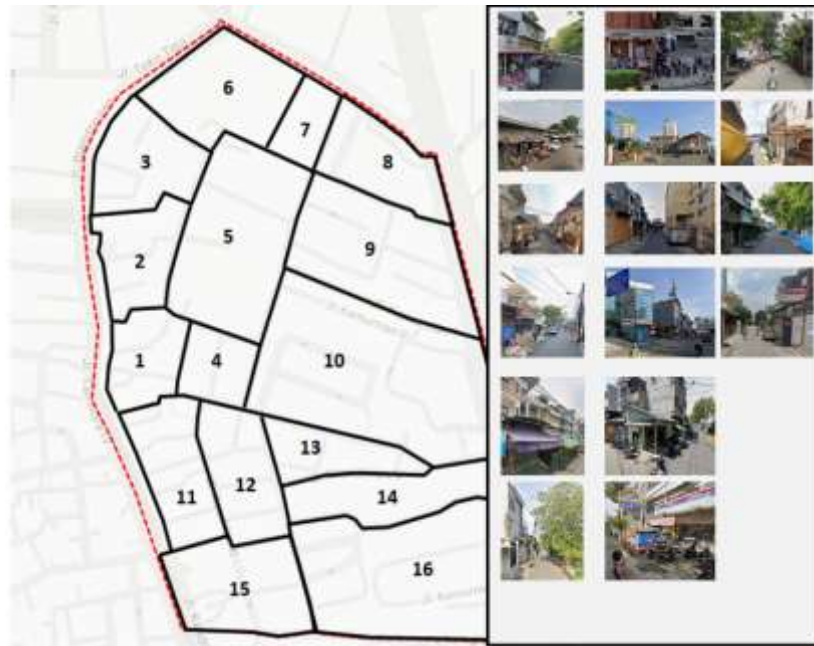
**Fig 3. building layout conditions in the glodok area, Jakarta, Indonesia**  
source : google mapa,2026

1) Building Setback Deviations (GSB/GMB): Strict and high compliance with building setback regulations is rigidly limited to sub-sectors directly adjacent to primary arterial corridors, most notably Sector 8 (which encompasses modern, large-scale blocks such as Pasar Jaya Glodok) and Sector 10. These areas exhibit organized building clearance distances and controlled podium alignment. Conversely, massive, systemic violations of the Building Setback Line (GSB) and Building Frontage Line (GMB) serve as the defining characteristics of the interior core [25]. In Sectors 1, 2, and 3, structures have grown organically without standardized lot boundaries or visual orientation. This spatial compromise reaches a critical threshold in Sectors 6, 11, and 15, where self-built residential and commercial structures horizontally extend upper-floor structures (balconies), permanent canopies, and external iron staircases to the extent of encroaching upon the public right-of-way within narrow alleys, thereby constricting public air rights and blocking natural light penetration.

A comparative analysis of the building form and massing characteristics across the 16 selected sub-sectors reveals deep spatial fragmentation and a sharp structural dualism within the Glodok Urban Corridor. The physical fabric of the city is divided into two contrasting typologies: a formal-modern structure regulated by macro-planning systems, and organic-informal vernacular settlements that have grown spontaneously over time [24].

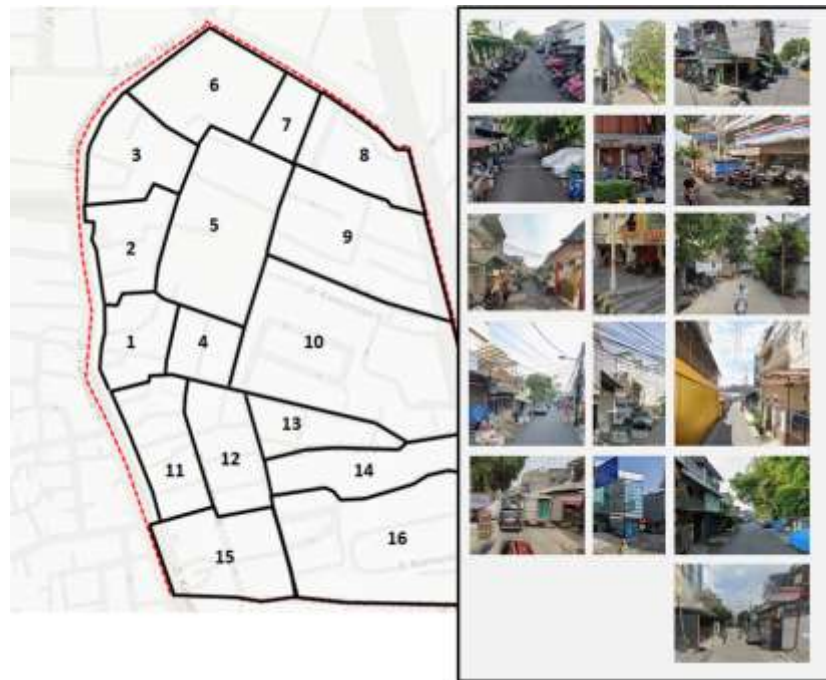
**Fig 4 . Condition of circulation and pedestrian systems in the glodok area, Jakarta, indonesia**  
source : google map,2026

- 1) **Pedestrian Space Deprivation and Shared Space Vulnerability:** Human-centered design is virtually non-existent across the entire internal network [15]. In Sector 6, the primary corridor of Pancoran Street operates as a highly congested, unregulated shared space where pedestrians, moving motorcycles, private vehicles, and informal commercial loading and unloading activities actively contest the same asphalt surface. Within the inner hinterland areas specifically Sectors 1, 2, 11, and 15 the physical street geometry is highly constrained, with path widths limited to a mere 1.5 to 3.5 meters. Several bottlenecks are so narrow that they can only accommodate one motorcycle at a time, yet these pathways remain severely obstructed by chaotic on-street motorcycle parking and the encroachment of residential domestic activities. The most severe degradation of pedestrian infrastructure occurs in Sector 100, where the public right-of-way for pedestrians is 100% occupied and physically overtaken by traditional wet market vendor stalls, triggering the total displacement of pedestrians and comprehensive spatial paralysis.

- 3) **Transit Integration and Non-Motorized Transport Barriers:** From a macro-planning perspective, Sectors 8 and 10 exhibit optimal Transit-Oriented Development (TOD) potential due to their direct spatial connectivity to Gajah Mada Street, the Transjakarta mass transit corridors, and the catchment areas of future MRT stations. However, this regional accessibility is severely degraded at the micro-level. The interconnecting sidewalks in Sector 8 suffer from profound functional degradation due to continuous encroachment by illegal motorcycle parking, street vendors, and commercial shop-house logistics. Furthermore, dedicated non-motorized transport corridors (bicycle lanes) are impossible to implement in Sectors 4, 5, 11, 12, 13, and 15 due to restricted street geometry, logistical box truck loading and unloading operations, and uncontrolled on-street illegal parking, effectively blocking opportunities for sustainable transit network modernization.

An evaluation of the circulation network highlights a fundamental misalignment between vehicle-centric infrastructure and human-centered design principles within a dense, historic urban core. The entire corridor experiences high local side friction, spatial paralysis, and a critical loss of safe spaces dedicated to non-motorized transportation.
