# Data Collection & Analysis Result

| <b>PROJECT</b><br>Heat Load Studies at The Grand Outlet,<br>East Jakarta Karawang | <b>CLIENT</b><br>Mitsubishi Jisho Design Asia Pte. Ltd.<br>Singapore |

| <b>Project:</b> | Environmental Measurement Survey of Grand Outlet Karawang, West Java, Indonesia |

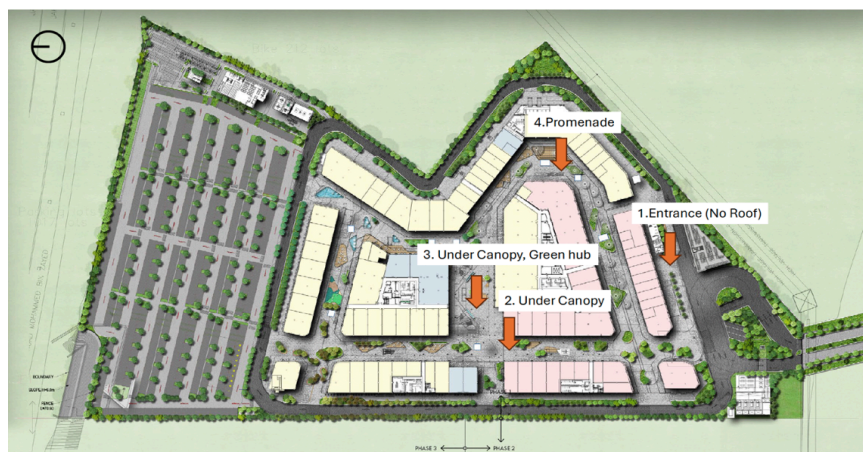
Figure.1 Ground Floor plan  
The Grand Outlet, East  
Jakarta Karawang Karawang,  
Bekasi, West Java (Source:  
Mitsubishi, 2024)

The Grand Outlet features five strategically selected Inside facility or Semi-Outdoor locations for environmental monitoring, each representing unique aspects of the facility's design and functionality. These include the open-air entrance, which captures transitional environmental conditions; the canopy areas on Levels 1 and 2, designed to assess shaded thermal comfort; the green hub, which highlights the influence of vegetation and water elements on Semi-Outdoor climate; and the promenade, focusing on pedestrian comfort under direct sunlight. Together, these key points provide insights into the facility's environmental performance and user experience.

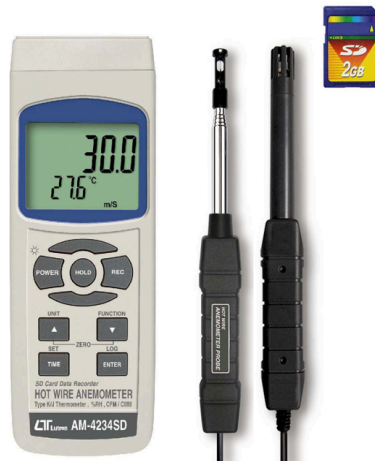
Figure. 5 Anemometer (Source: lutroninstruments.eu, 2024)

#### Lutron AM-4234SD Hotwire Anemometer:

Wind Speed (m/s), Air Temperature (TA, °C), Humidity (%), Dew Point (°C)

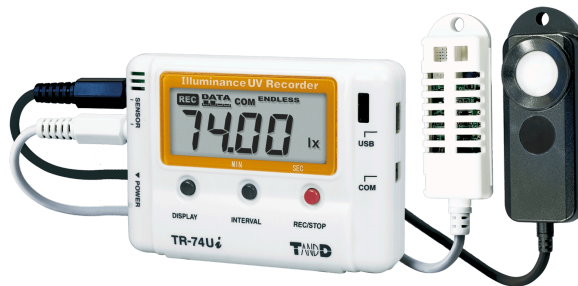
Figure. 7 T and D TR-74Ui (Source: *tandd.com*, 2024)

Air Temperature (TA,  $^{\circ}\text{C}$ ), Humidity (%), Illuminance (Lux)

The TR-74Ui data logger was programmed to automatically record temperature and humidity at fixed intervals throughout the day. After completing the recording phase, the data was retrieved by

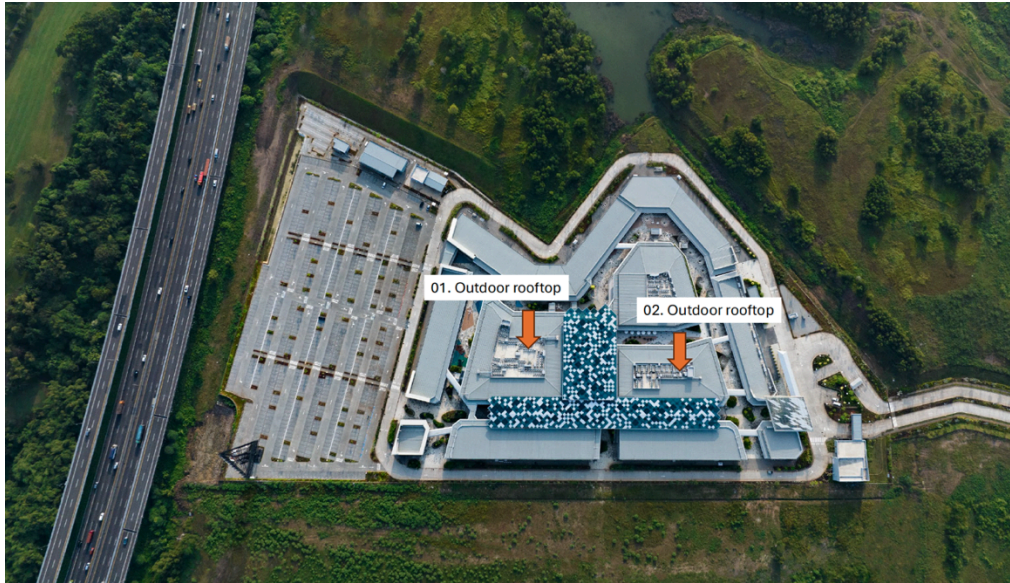
Figure. 9 Top View The Grand Outlet, East Jakarta Karawang Karawang, Bekasi, West Java (Source: Mitsubishi, 2024)

The environmental monitoring setup at the Grand Karawang Outlet includes two strategically positioned points on the rooftop to capture detailed outdoor conditions. These points, as shown in the below image, are located at 01. *Outdoor rooftop* and 02. *Outdoor rooftop*, ensuring comprehensive coverage of the facility's external environment. Using Ambient Weather WS-2000 weather stations, these locations allow for precise measurement of parameters such as temperature, humidity, wind speed, solar radiation, and rainfall, providing valuable data to assess and optimize the facility's environmental performance in response to the surrounding tropical climate.

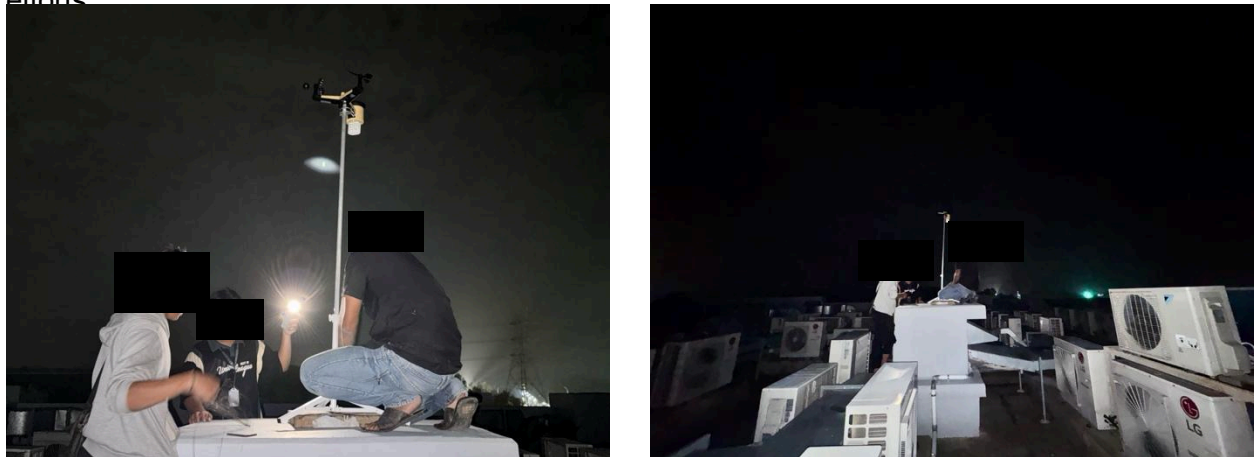
Figure. 10 Research Team is Preparing The Equipment on The Rooftop (Source: Research Team, 2024)

At each rooftop location, we have installed Ambient Weather WS-2000 weather stations, known for their high precision and multi-parameter measurement capabilities. These weather stations are equipped to monitor key outdoor conditions, including temperature, humidity, wind speed, wind direction, solar radiation, and rainfall intensity. The WS-2000's advanced sensors and real-time data logging features allow us to continuously gather critical environmental data, which is then analyzed to support the facility's thermal performance and user comfort optimization efforts

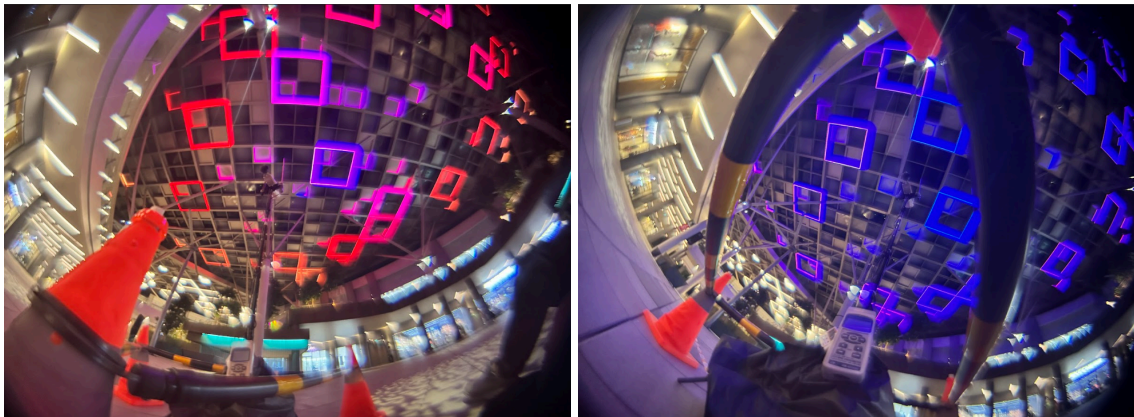
**Fish Eye Surrounding Photos**

| Beneficiary | | | |
|---|---|---|---|
| <p>The Green Hub area is designed with two large fans positioned on the east and west sides to enhance airflow and maintain a comfortable environment. Additionally, the area features two water elements: a pond and a fountain, which contribute to a cooler and more humid microclimate.</p> <p>Vegetation is placed at a distance of 15 meters from the Green Hub point. Whereas Outlets were on the front and back of the equipment.</p> | | | |

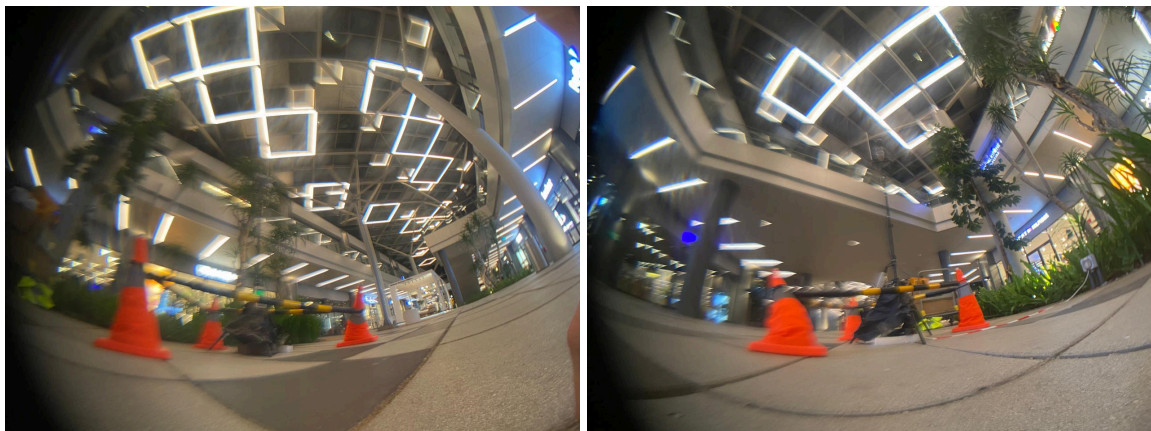
**Fish Eye Surrounding Photos**

| Beneficiary | | | |
|---|---|---|---|
| <p>The equipment is positioned in the corridor, maintaining a distance of 3 meters from the vegetation and 4 meters from the outlet shop. Additionally, the placement is near the fans, which may affect the data collection process due to potential air circulation interference. Adjustments are necessary to align with the mall's conditions while considering visitor circulation and ensuring accurate data collection.</p> | | | |

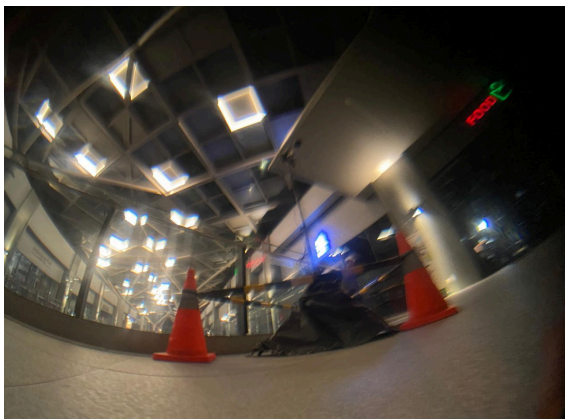
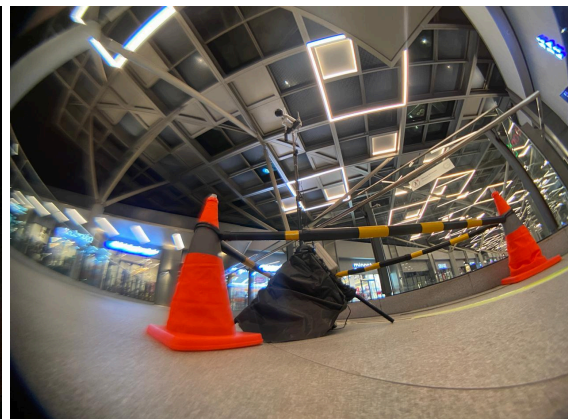
| Beneficiary | | | |
|---|---|---|---|
| <p>The measuring instrument is located in the connecting area between outlets and close to the mall's void. The fan is positioned far from the instrument, and the instrument is placed relatively close to an open area. It is installed on the second floor, where no vegetation is present. The distance from the outlet to the instrument is 6 meters.</p> | | | |

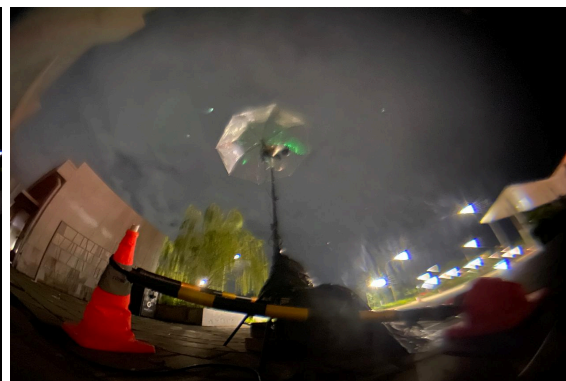
| Beneficiary | | | |
|---|---|---|---|
| <p>The instrument is located in an open area without a canopy, positioned 10 meters from the FCC and 15 meters from the entrance. It is 7 meters away from vegetation situated in front of the FCC and faces vehicular circulation. To adapt to rainy conditions without a canopy, a transparent umbrella is used to ensure that data collection can proceed effectively.</p> | | | |

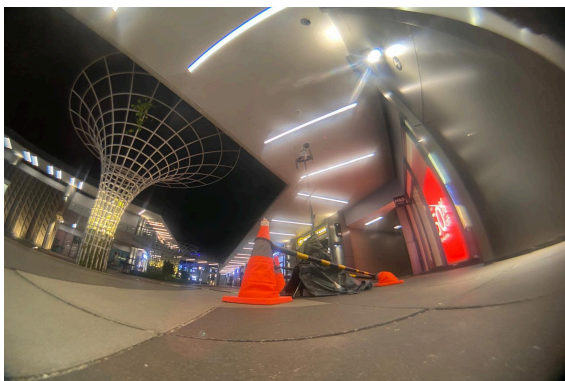
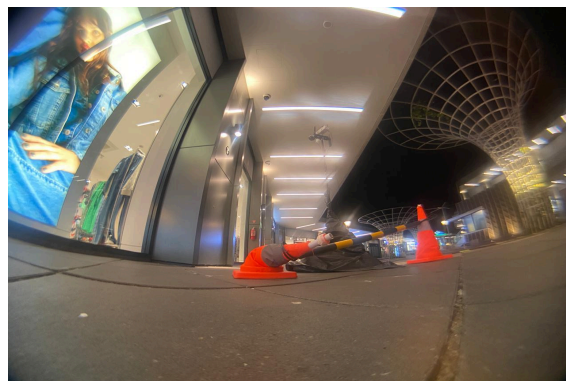
| Beneficiary | | | |
|---|---|---|---|
| <p>The measuring instrument is located 2 meters from the shopping outlet, near the corridor leading to the restroom. It is positioned 1 meter from the plaza, which features numerous umbrellas. The placement is in an open area.</p> | | | |

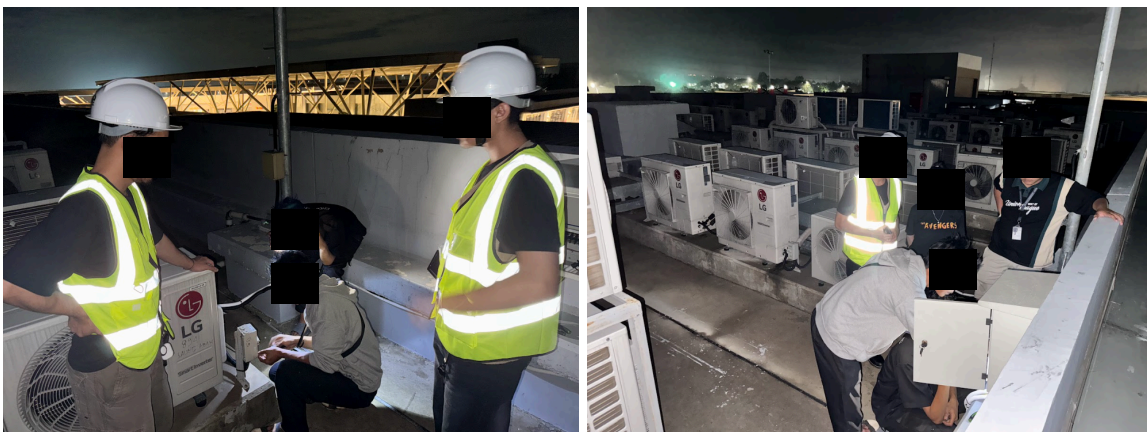
**Installation Photos**

The equipment will be installed on the 3rd floor of a utility building, at a height of 9 meters above ground level. The installation area is open and unobstructed, ensuring the device can accurately collect data from the surrounding environment. It will be placed adjacent to the existing green hub area and accessed via an emergency staircase. The monitoring range is approximately 15-30 meters in radius.

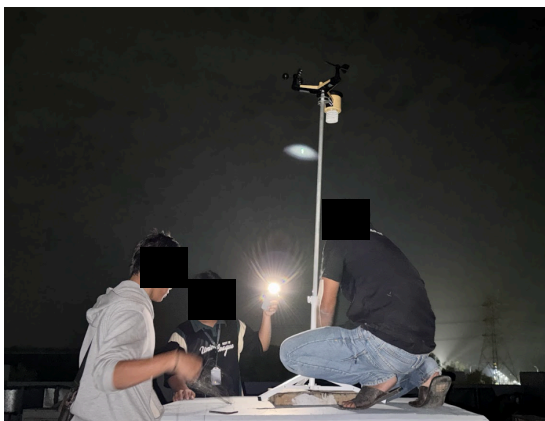
### Installation Photos

| North | South | West | East |
| - | - | - | - |
| <p>The equipment will be installed on the 3rd floor of a utility building, positioned 9 meters above ground level. The installation site is open and unobstructed, allowing the device to effectively collect environmental data. Due to exposure to high wind speeds, a stabilizing weight, such as stones, will be required to secure the equipment in place. The device will be located adjacent to the existing green hub area and accessed via an emergency staircase. The monitoring range is designed to cover a radius of approximately 20-35 meters.</p> | | | |

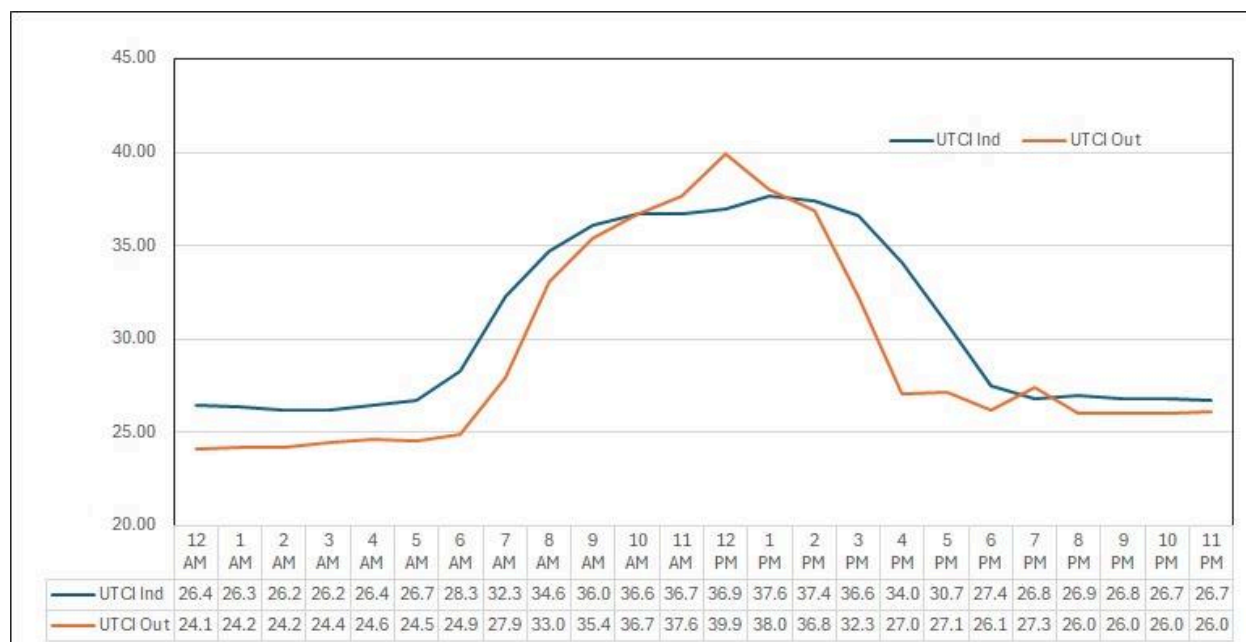
The graph shows an interesting finding where the UTCI outdoor values are lower than those observed under the canopy, even during nighttime hours. This suggests potential issues with the design or configuration of the under-canopy space, which may be contributing to higher thermal stress compared to the outdoor environment. This anomaly could arise due to several factors:
