Management of Iatrogenic Problems during Root Canal Treatment

Yason Nielsen Argosurio ¹, Meiny Faudah Amin ²[§], Elline ²

ABSTRACT

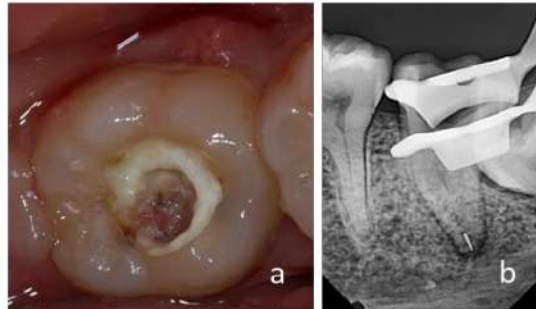
A 27-year-old female patient complained of pain in the lower left back tooth and intermittent secretion of a yellowish, salty fluid beginning one month prior. The tooth had undergone treatment, and a temporary filling had been placed. Upon clinical examination, it was discovered that the lower left second molar had a fistula and a temporary filling

that was partially opened (Figure 1a). Examinations of percussion, palpation and mobility were all positive. A radiographic examination of the roots revealed that there were three root canals. A fragment of separated files is thought to be the radiopaque appearance in the apical part of the mesial root canal. The lamina dura is severed in the apical third and the periodontal ligament is noticeably dilated (Figure 1b). WHO diagnosed tooth 37 as having a persistent apical abscess and had previously started treatment. The treatment approach includes root canal retreatment by removal of fragments of separated files and direct composite resin restoration.

Figure 1. A. Preoperative clinical view of 36. B. Preoperative radiographic periapical.

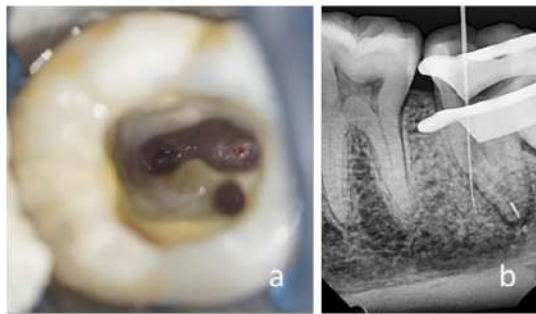
Another problem that occurred during the attempt to reach the fragment was lateral side perforation. When the canal system is being biomechanically prepared, ledge formation is possible, especially if the canals are more curved. The instrumentation technique, instrument type, root canal curvature, tooth type, working length, master radicular file size, clinician level of experience, and canal location are just a few of the variables that might affect ledge formation. A ledged canal makes endodontic treatment challenging and may affect the prognosis. When a ledge forms, management of it will be made easier by early detection of its position using radiography and magnification.³

Figure 2. A. Perforation of root canal wall. B. Confirmation of perforation.

Using a novel biocompatible material to seal the perforation site will reduce periodontal inflammation and speed up healing. MTA, which was initially marketed as a perforation repair material, was one of the first calcium silicate cement used in dentistry.⁷ imilar to this case, MTA was used to seal the mid-root perforation. MTA is a suitable material for more than just perforation repair. When there is a mid-root perforation, it can also be used as the obturation material.¹ It can stimulate cementoblasts and induce them to create a cement matrix. It is excellent for use as a root restoration material since it is

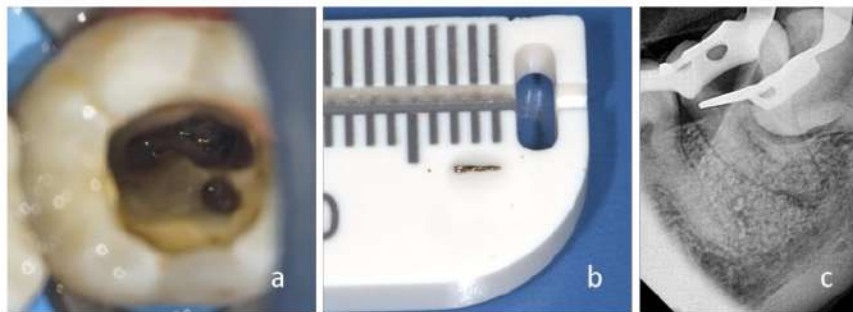
An ultrasonic instrument was used in this case to try to retrieve the fragment. The safest and most popular way to retrieve a separated endodontic instrument is by using ultrasonic tips magnified by a dental operating microscope. Using the ultrasonic tip to remove separated endodontic instruments has an 80% success rate.⁶ The prepared ultrasonic tip was small enough to properly visualize the canal under a microscope as well as fit into the opening on the inner wall.^{1,3} To avoid a temperature increase and the breakage of the ultrasonic tip or the broken instrument, the ultrasonic tip was intermittently activated at the lowest power setting that allowed the least amount of dentin removal.¹ Dry ultrasonic tips with a diamond coating were used around the fragment, and

then ultrasonic vibrations with ultrasonic tips made of nickel titanium were used to remove the fragment.⁴

Figure 3. A. Removal fragment of separated file. B. 2mm fragment of separated file. C. Confirmation of fragment removed.

The preparation for instrument retrieval proceed by deepening the space until the fractured instrument is seen moving.¹ Until the separated file is removed, push-pull motions with an ultrasonic activator should be used in the space between the separated file and the inside curvature of the canal.³ The retrieval procedure should start after the separated file is loosened. For the fractured instrument to flow out of the canal, there needs to be more room between it and the canal wall than it is a diameter. The use of a staging platform should not be tried if the tool is separated in the curved area of the apical canal beyond the straight segment of the canal because lodging, perforation, or severe dentin loss may occur.¹

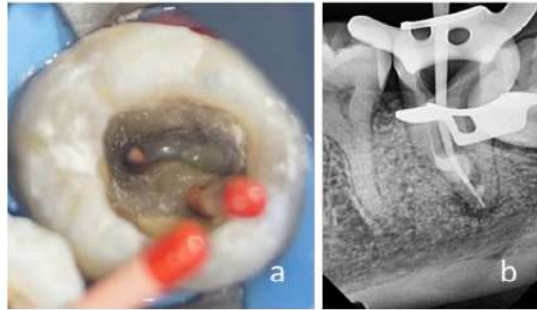
activation (EndoActivator, Dentsply Sirona). K-file #15 (Dentsply Sirona) was used for apical patency, and K-file #25 (Dentsply Sirona) was used for apical gauging. Periapical radiography confirmed the presence of the master gutta cone #25 (Figure 4a and b). Pastes containing calcium hydroxide ((Ca(OH)₂) were used to sterilize the root canals (UltraCal XS, Ultradent).

Figure 4. A. Master gutta cone #25. B. Confirmation of master gutta cone #25

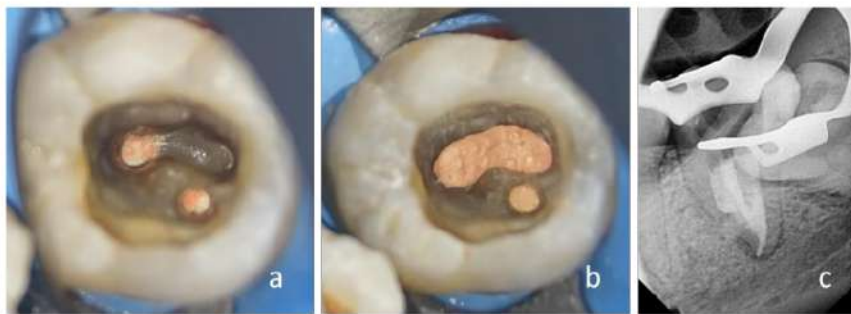
The patient had no subjective or objective symptoms at the subsequent visit, and the fistula was no longer present. Root canal cleaning with 5.25% NaOCl, 17% EDTA, and 5 ml of 2% Chlorhexidine for 2-3 minutes, changing solutions after each minute. A sonic activator was used to activate each irrigation fluid (EndoActivator, Dentsply Sirona). System B was used to obturate using a continuous wave compaction method. The gutta-percha master cone was coated with sealer before being inserted into the root canal (AH Plus Root Canal Sealer, Dentsply Sirona). Using a heat carrier system, the gutta-percha was cut to the apical 1/3, and then a hand plugger was used to compact it (Figure 5a). Using a backfill method and a hand plugger to compact it, the apical 2/3 of the orifice was obturated (Figure 5b). Radiography validated the obturation (Figure 5c).

Figure 5. A. 1/3 Apical obturated. B. 2/3 Midroot obturated. C. Confirmation of root canal obturated.

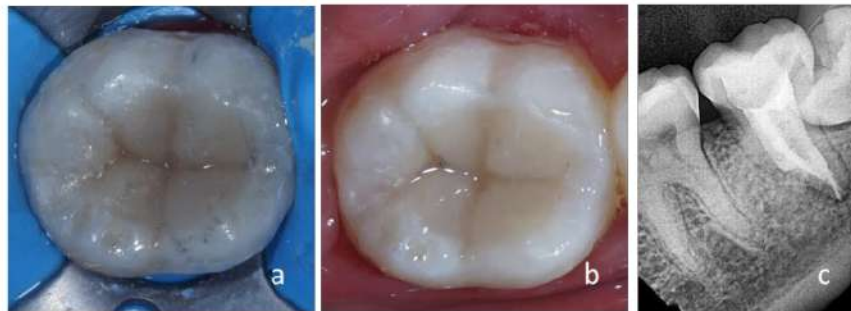
With a total-etch method, 37% phosphoric acid (DE TREY CONDITIONER 36 SYR, Dentsply Sirona) was used to etch the cavity's whole surface. After applying the adhesive material (Prime & Bond Universal Dentsply Sirona), it was polymerized using light curing for 20 seconds. A flowable resin composite (PALFIQUE®, Tokuyama) was used to create an orifice barrier, which was then polymerized using light curing for 20 seconds. Packable composite resin (PALFIQUE®, Tokuyama) was applied incrementally and obliquely from the bottom of the cavity to the cusp before being polymerized using a light cure for 20 seconds. Using the cusp by cusp method, build the occlusal plane to match the ideal dental morphology (Figure 6a). After removing the rubber dam, articulating paper was used to check for contact occlusion and articulation. Using a composite polisher set, polishing and finishing is performed (Figure 6b). Final periapical radiography to confirmed the endodontic treatment (Figure 6c).

Figure 6. A. Composite resin restoration. B. Finishing and polishing. C. Post operative radiographic periapical.
