IMPLEMENTATION OF 5D BUILDING INFORMATION MODELLING (BIM) SYSTEM ON QUAY WALL STRUCTURE BY PAYING ATTENTION TO CLASH DETECTION (CASE STUDY: PROJECT PATIMBAN PACKAGE 6)

Ruri Welda Palensia¹, Endah Kurniyaningrum², M. Zaki³, Darmawan Pontan⁴
^{1,2,3} Master of Civil Engineering Program, Universitas Trisakti, Indonesia
Email: ruriweldapalensia@gmail.com

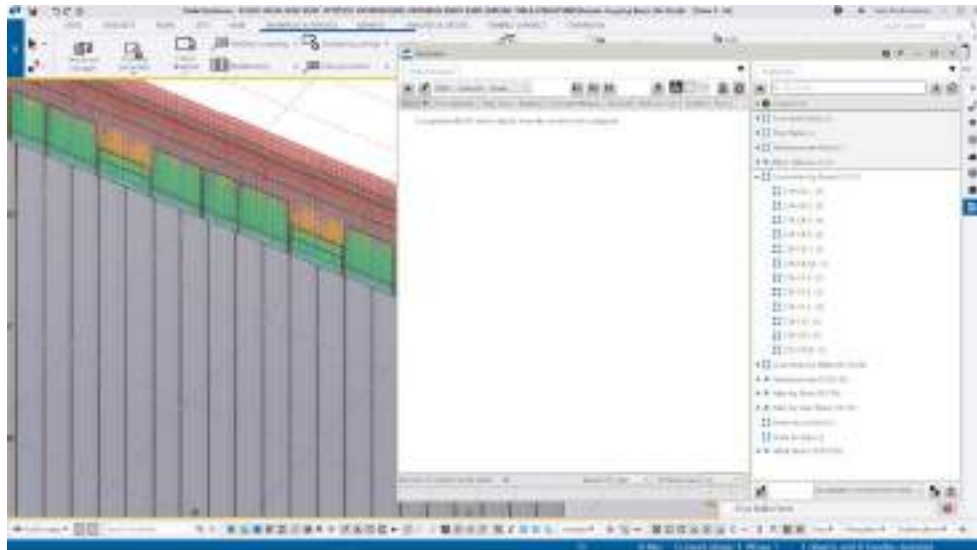
Picture 3. 3D BIM Display (Secondary Data Input on Tekla)

The scheme is validated through case studies on real projects, with participants described in the table. In the previous project, cost savings were made through clash detection analysis and also used case study methods to verify the work of the resource persons. Interviews were conducted to understand the process of clash detection, the practices applied in categorizing clash detection, and the procedure for its completion. The following is the layout of the Quay Wall Structure taken from DED data which will be processed into a 3D model in Tekla BIM.
