Inclination change of endodontically treated teeth

Inclination change of endodontically treated teeth with post core crown

Riesta Dewi¹, Tien Suwartini^{2*}, Dina Ratnasari²

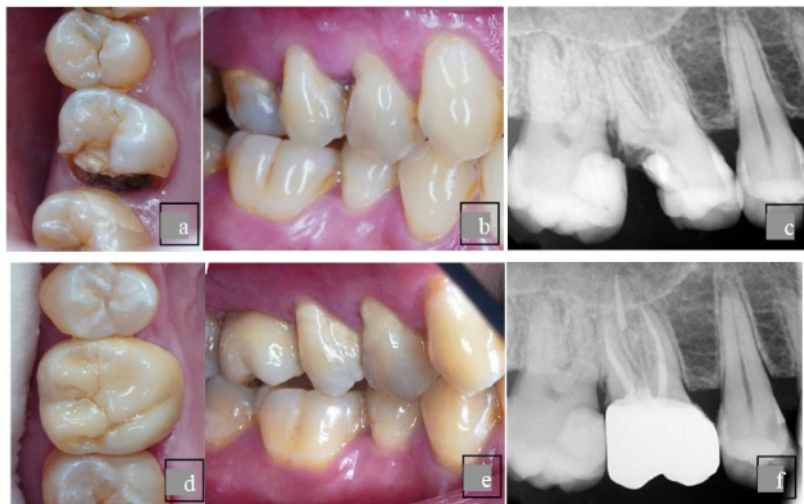
Figure 1. (a) and (b) **Pre-Operative** clinical image of right maxillary first molar (c) **Pre-operative** periapical radiograph showing radiolucency that extends disto-occlusal and has reached the pulp (d) and (e) **Post-Operative** clinical image endodontic treatment continued intentional inclination change with post-core crown restoration and (f) **Post-operative** periapical radiograph showing radiopaque images along the mesiobuccal and distobuccal canals and the apical 1/3 of the palatal root canal filled with gutta perca, 2/3 of the palatal root length was filled with fiberpost material. There was a radiopaque image on the crown showing a zirconia crown restoration.

radiography showed normal apical tissues. Diagnosis of previously initiated therapy on tooth 16 was made. The endodontic treatment procedure was done under 4.3x magnification. Root canal treatment was done under rubber dam isolation. Biomechanical preparation was carried out using heat treated rotary files followed by 5.25% NaOCl, saline, and 17% EDTA irrigation with sonic activation for 1 minute. The obturation was carried out employing a single cone technique along with a bioceramic sealer. Subsequently, a fiber post was positioned in the palatal canal, and a core build-up was performed using dual-cure core material. Preparations for palatal reduction of between 3 - 4 mm to change the inclination more towards the buccal direction. Zirconia was the material of choice for the crown in this particular case. Cementation of the crown was done using self-etch self-adhesive dual cure resin cement. At 3 months follow-up, the tooth showed favorable result clinically and radiographically with absence of symptoms.
